Manhole Inspection Summary

Manhole # S31YY1015MH

Location Address: **109 UPNOR RD**

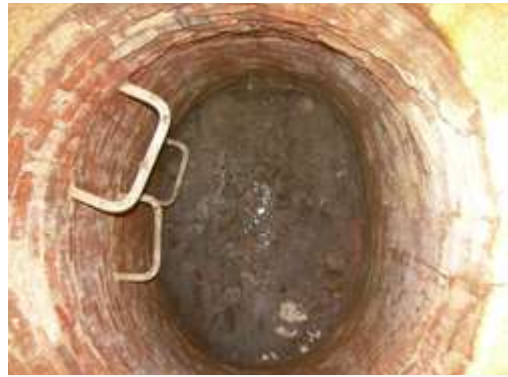
Top View

Channel debris.

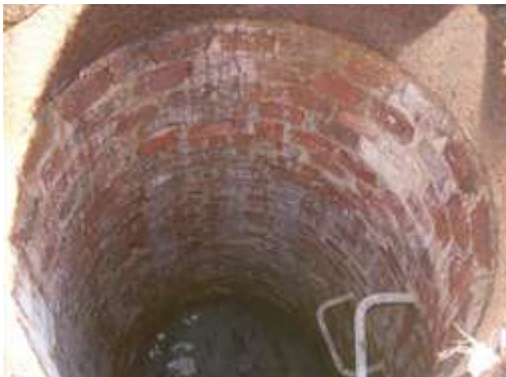
Defect

Frame Offset: **0** (in.) Condition: ☐ Sound ☐ Cracked ☒ **Leaks**

Condition: ☐ Sound ☐ Cracked ☐ Root Intrusion ☐ Loose Brick ☒ **Deteriorated**

Infiltration: ☐ None ☒ **Joint** ☐ Cracks ☒ **Mortar** ☐ Roots ☐ Wall

Frame leaks. Adjustment deterioration and infiltration. Barrel infiltration - other side.

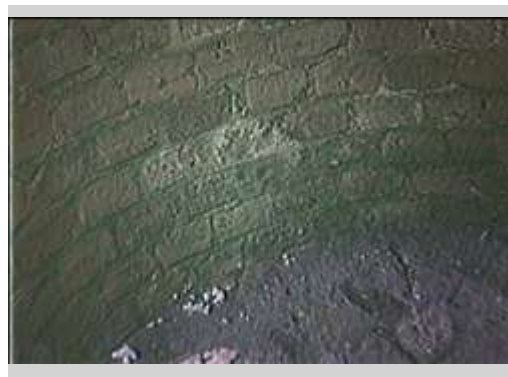
Defect

Condition: ☐ Sound ☐ Cracked ☐ Root Intrusion ☐ Loose Brick ☒ **Deteriorated**

Infiltration: ☐ None ☐ Joint ☐ Cracks ☒ **Mortar** ☐ Roots ☐ Wall

Barrel deterioration and infiltration.

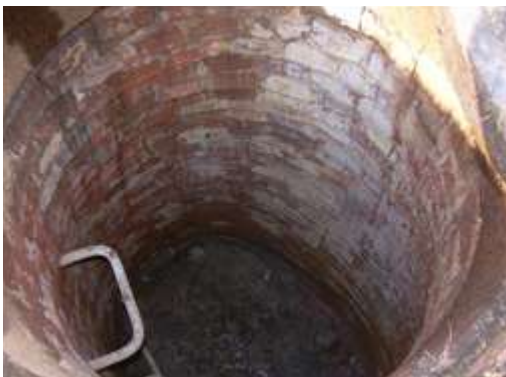
Defect

Frame leaks. Adjustment deterioration and infiltration. Barrel infiltration.

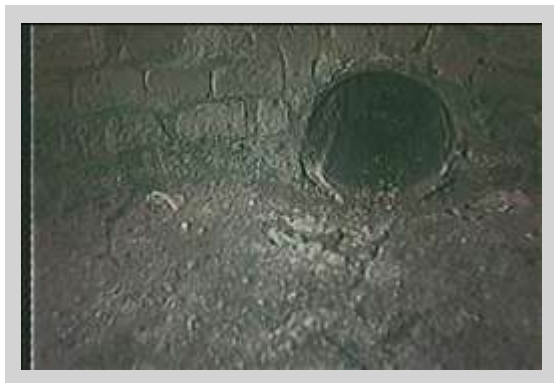
Pipe Out @ 12 O'Clock

Channel debris.

Deposits: ☐ None ☒ **Mud** ☐ Sludge ☒ **Debris** ☐ Grease

Pipe Seal Cond: **Cracked**
